## Ridge Road Water Tank Improvements

Perkasie, PA

### Perkasie Regional Authority

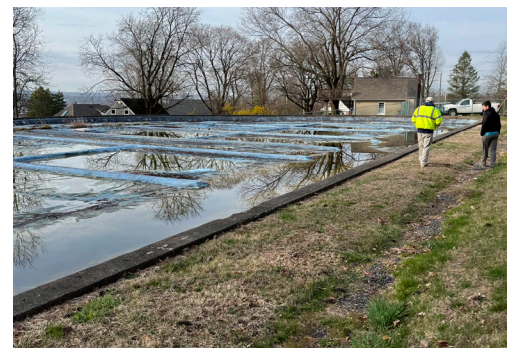
**Existing Conditions** - Built in 1896, the existing reservoir was created to service the existing Borough of Perkasie. Built with a brick and concrete foundation, the tank was split down the middle by a dividing wall in order to allow for easier maintenance and upkeep. As such, the structure lasted over 120 years and was still in decent shape.

However, the increase in technology and threats that came over the course of the century led to the need for a cover, which was implemented in the 1970s. With a fabric cover that had decomposed egregiously (outliving its expected lifespan by nearly two decades), the tank was in dire need of repair, and given the relative vulnerability of an unsecured tank, the Authority decided to simply replace the entire structure. Of the various options available, a pre-stressed concrete tank was selected due to its ease of use and its durability, with the intention for it to last another hundred years.

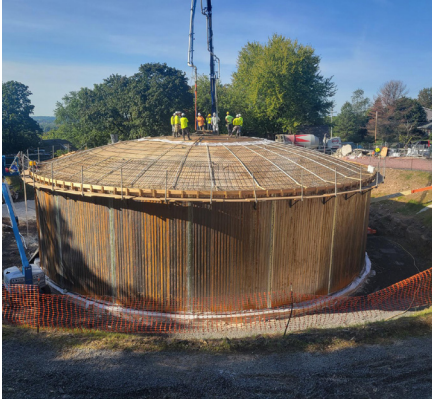
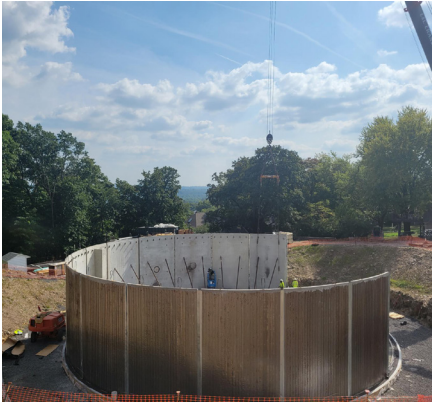
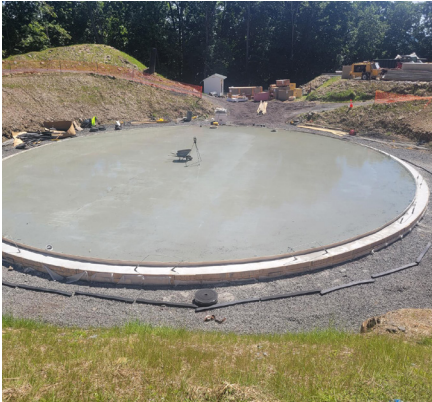
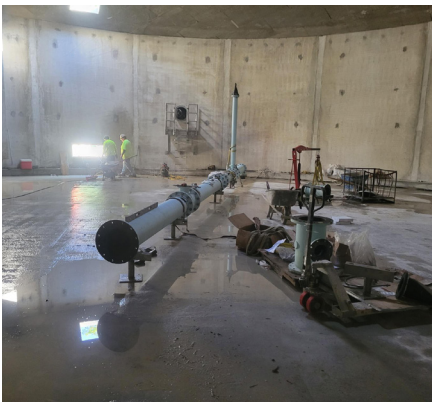
**Building Process** - After the original reservoir was demolished and the subgrade prepared, the foundation of the tank was poured. While the floor cured, the tank wall panels were precast on-site around the perimeter of the tank. The panels were constructed through an efficient stack-casting process in casting beds shaped to the curvature of the tank wall. A crane was then utilized to erect the panels, and shotcrete was used to fill in the seams.

For the construction of the roof, reinforcing steel was placed in perpendicular directions throughout the dome shell, and then the concrete was poured onto the form. Shotcrete was again used to coat the outer layer of the tank, insulating the metal panel reinforcements. And all this was ultimately followed with a few layers of Tammscoat, a LEED-approved coating used to extend the life of the tank (as well as to recolor it).
